Arkansas HomeTech Inspections, Inc.

CONFIDENTIAL INSPECTION REPORT

3456 Main Street , Fayetteville, Arkansas 72704

SUMMARY REPORT

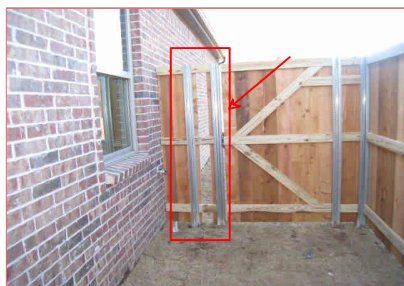
2.1 - Several of the fence planks have not been installed at this time.

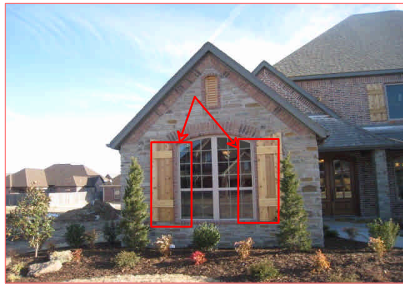
2.2 - The doors and windows should be sealed to prevent moisture intrusion and energy loss.

The doors and windows should be sealed to prevent moisture intrusion and energy loss - *Continued*

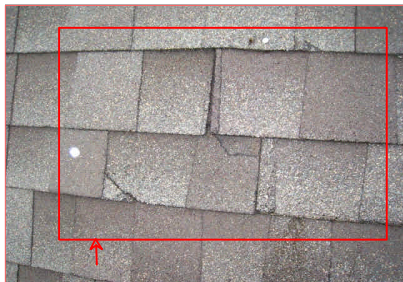
3.1 - There are damaged shingles in the south valley and they should be replaced.

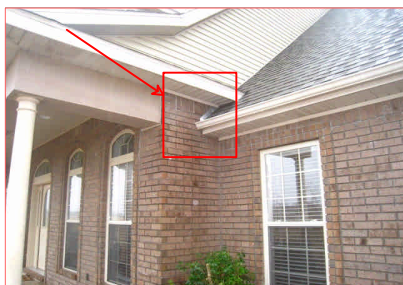
3.2 - Kickout flashing should be added where the gutter abuts a wall to help prevent water damage.

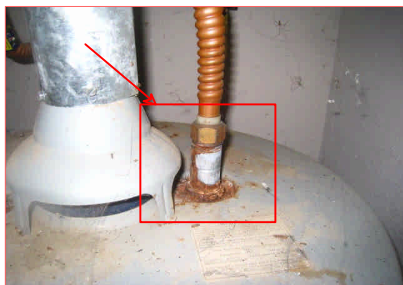
5.1 - There is mineral encrustation on the fittings, they should be cleaned to ensure the fittings are not still leaking.

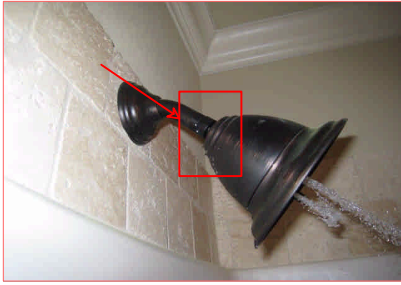
12.2 - There is a leak at the shower head and it should be serviced.

There is a leak at the shower head and it should be serviced - *Continued*

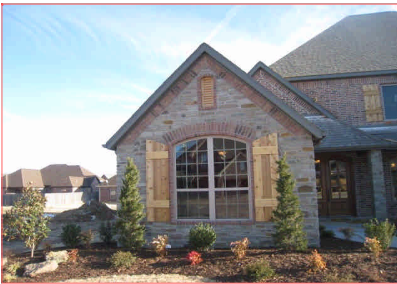
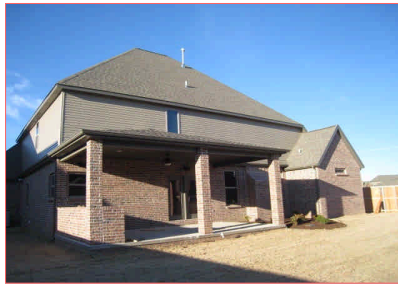
The house walls are finished with a combination brick veneer and vinyl siding.

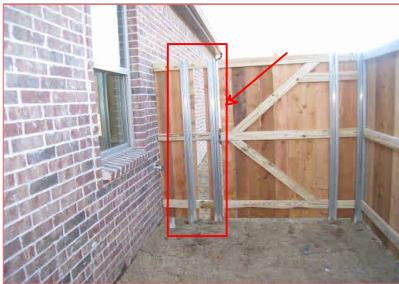
Several of the fence planks have not been installed at this time.

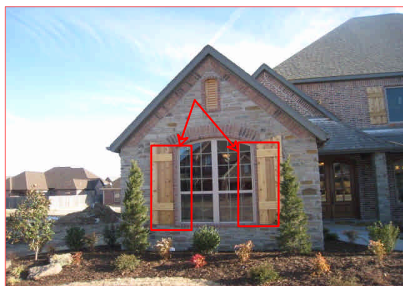
The doors and windows should be sealed to prevent moisture intrusion and energy loss.

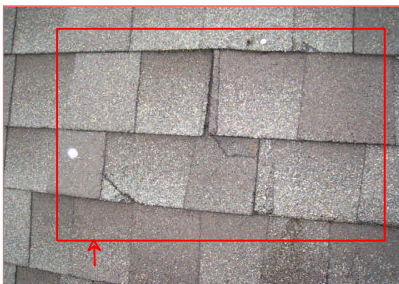
There are damaged shingles in the south valley and they should be replaced.

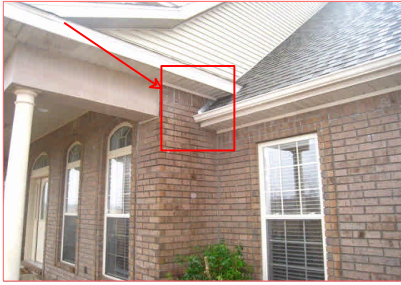
Kickout flashing should be added where the gutter abuts a wall to help prevent water damage.

Kickout flashing should be added where the gutter abuts a wall - *Continued*

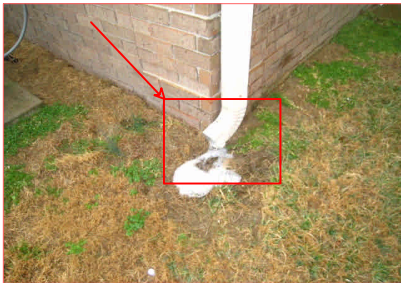
The gutters appear to be in acceptable condition. However, without water in them it is difficult to judge whether they are correctly pitched to direct water into the downspouts, but they should function as they were intended.

It would be prudent to add leaders and/or splash blocks at the bottom of the downspouts to promote positive drainage and divert water away from the perimeter footings.

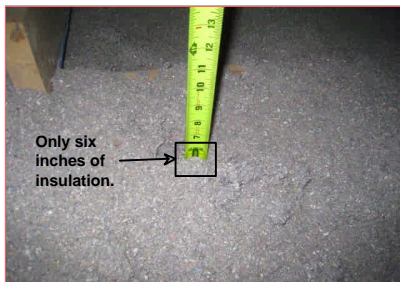
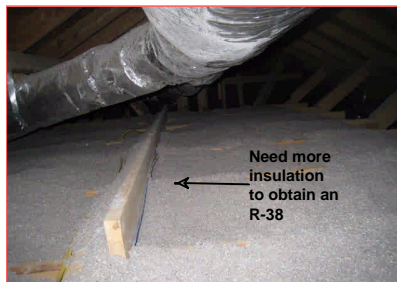
There are areas lacking insulation and more insulation should be added.

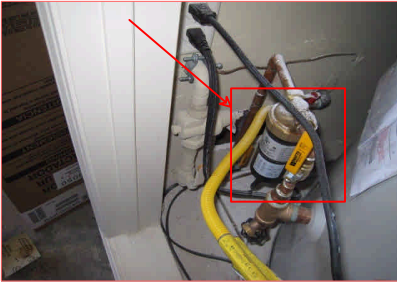
The residence has a circulating system, or hot water loop, that we did not evaluate. However, the components of circulating systems have a shorter design-life than many other components, because their pumps often run continuously and because the abrasive action of moving water causes leaks, and particularly at fittings where the flow changes directions.

The residence has a circulating system or hot water loop that we did not evaluate - *Continued*

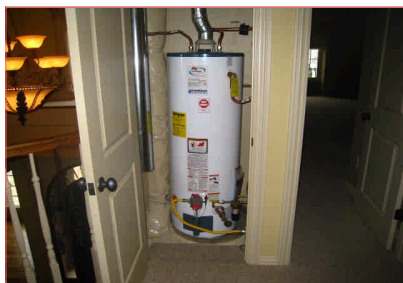
Hot water is provided by a three year old 50 gallon water heater located in the garage closet. Brand Name State Select Model No. MI0840239UT Serial No. 18947HG98

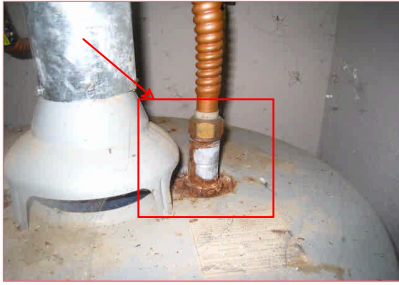
There is mineral encrustation on the fittings, they should be cleaned to ensure the fittings are not still leaking.

There is mineral encrustation on the fittings and they should be cleaned - *Continued*

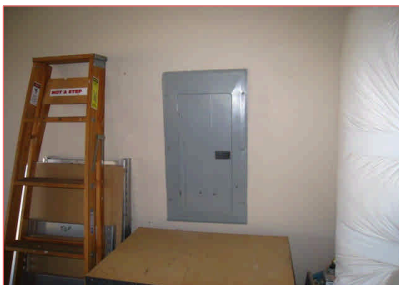
The residence is served by a 200 amp, 220 volt panel, with 4/0 aluminum entrance conductors and the panel is located inside the garage.

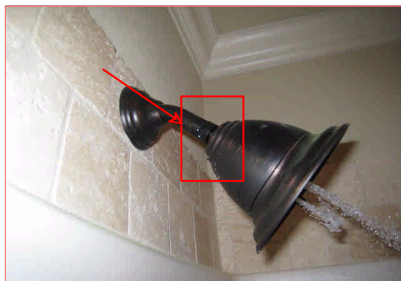
There is a leak at the shower head and it should be serviced.
